Manhole Inspection Summary

Manhole # S17M__005MH

Insp Date: **4/16/09 2:16 PM**

Location Address: **WEST SIDE SHOPPING CENTER**

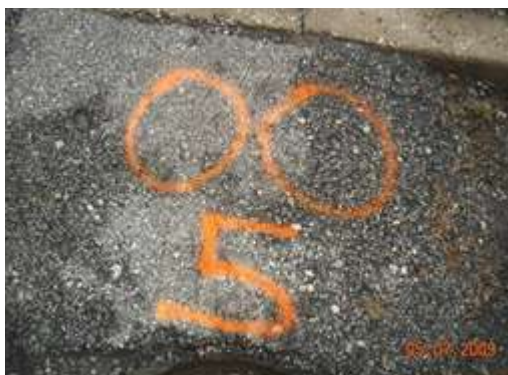
MISC.

PAVEMENT MARKED

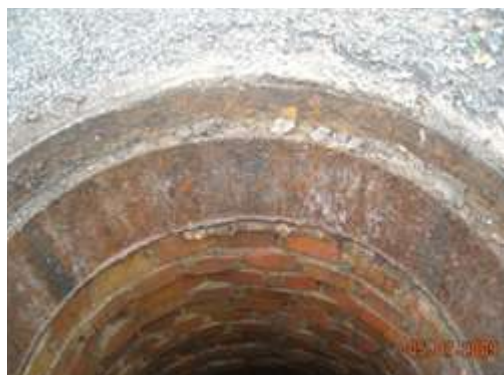
Defect 1

Frame Offset: **0** (in.) Condition: ☐ Sound ☐ Cracked ☒ **Leaks**

FRAME LEAKS

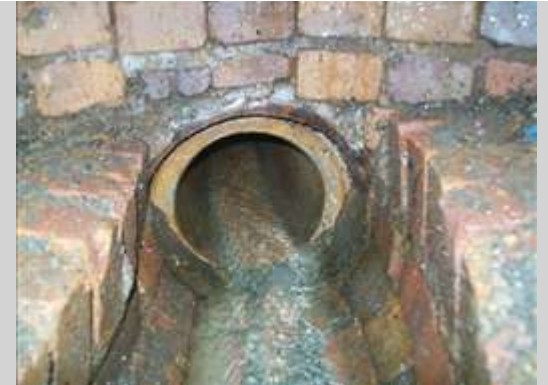
12 O'Clock Outflow

8 in. Circular Gravity Sewer
Pipe Out @ 12 O'Clock

Pipe Height: **8.4** (in.) Rod and Bar (Angled)
Pipe Material: **Clay** ☐ Pipe Lined
Invert Depth: **15.25** (ft.) Flow Characteristics: **Slow**
Deposits: ☒ None ☐ Mud ☐ Sludge ☐ Debris ☐ Grease
Silt Depth: **0** (in.) Deposits Extent:
Infiltration: **None** Pipe Seal Cond: **Sound**

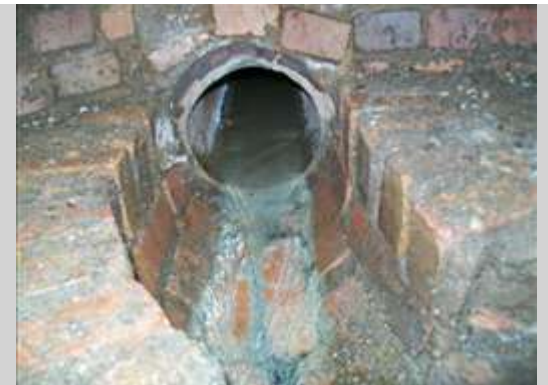
8 O'Clock Inflow

8 in. Circular Gravity Sewer
Pipe In @ 8 O'Clock

Pipe Height: **8.4** (in.) Rod and Bar (Angled)
Pipe Material: **Clay** ☐ Pipe Lined
Invert Depth: **14.84** (ft.) Flow Characteristics: **Slow**
Deposits: ☒ None ☐ Mud ☐ Sludge ☐ Debris ☐ Grease
Silt Depth: **0** (in.) Deposits Extent:
Infiltration: **None** Pipe Seal Cond: **Sound**
